STABILITY ANALYSIS OF DRILLING WASTE SUMPS, WESTERN ARCTIC CANADA

Rae Landriau
 R Landriau
 2nd year MSc. student
 Supervisor Dr. Chris Burn

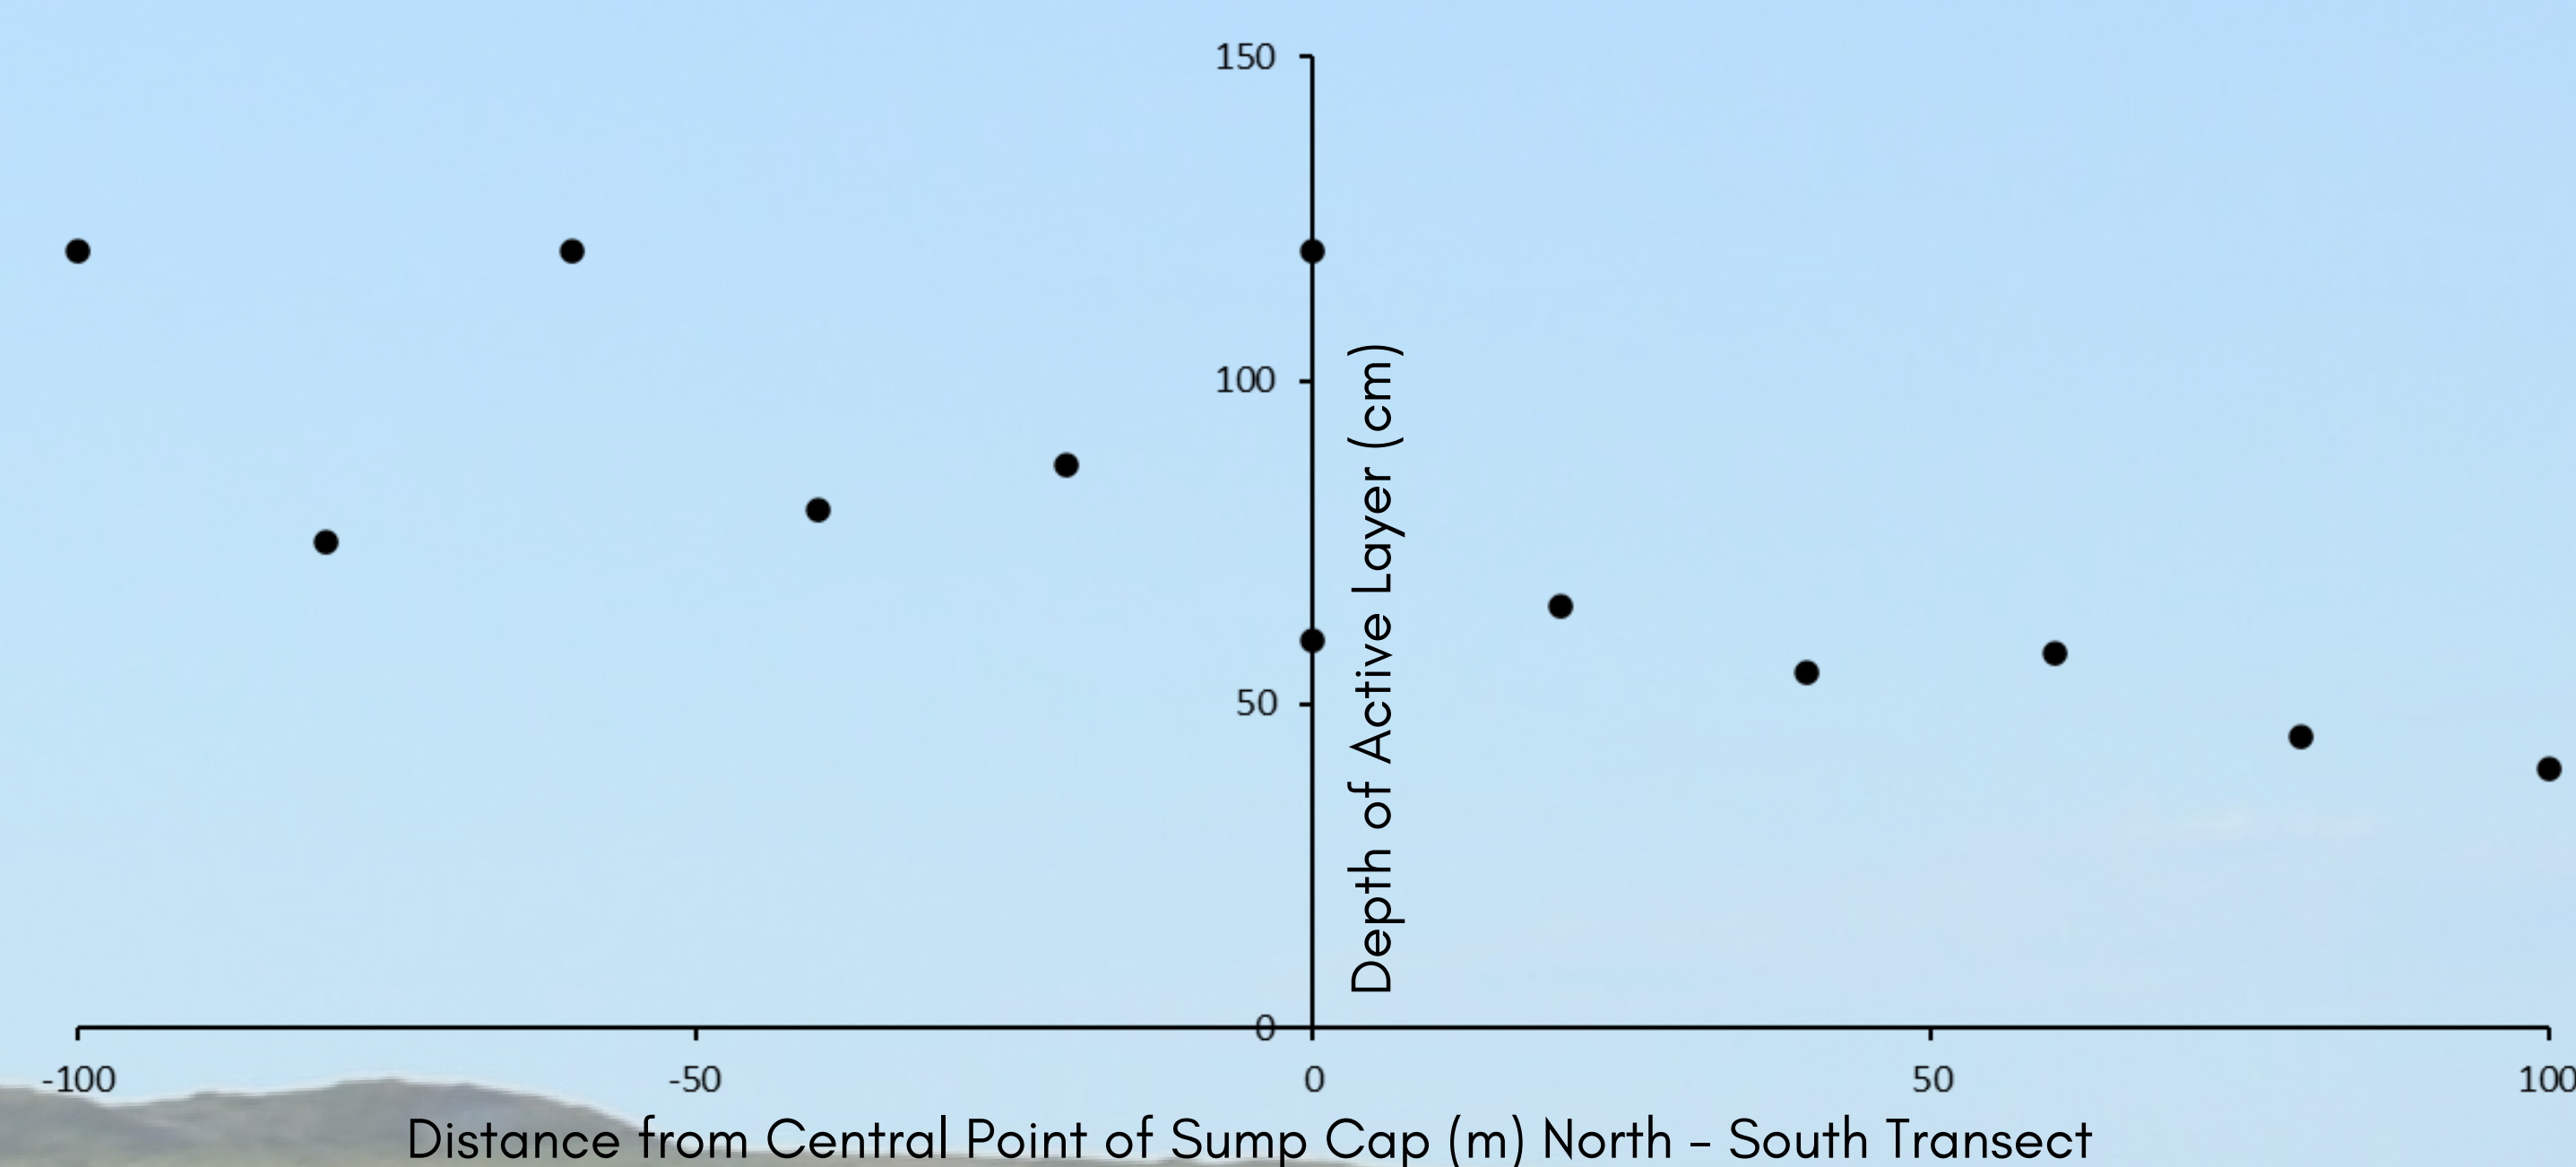
Figure 3. Measured active layer depths at F-29 North South transect

- Figure 2D indicates drainage from sump towards the northwest where readings are elevated compared to background undisturbed terrain
- EM31 Readings from August 2022 (Figure 2D) indicate a higher concentration of KCl in northwest transect than 2005 EM31 map (Figure 2C) which is indication of leaching of materials
- Summer 2022 data indicates active layer depths are typically greater near the sump cap, reaching a maximum of 120 cm (Figure 3), the limit of the thaw probe used.
