Settling lands: Revealing spatiotemporal patterns of ground movement under community infrastructure in Mayo, Yukon

Background

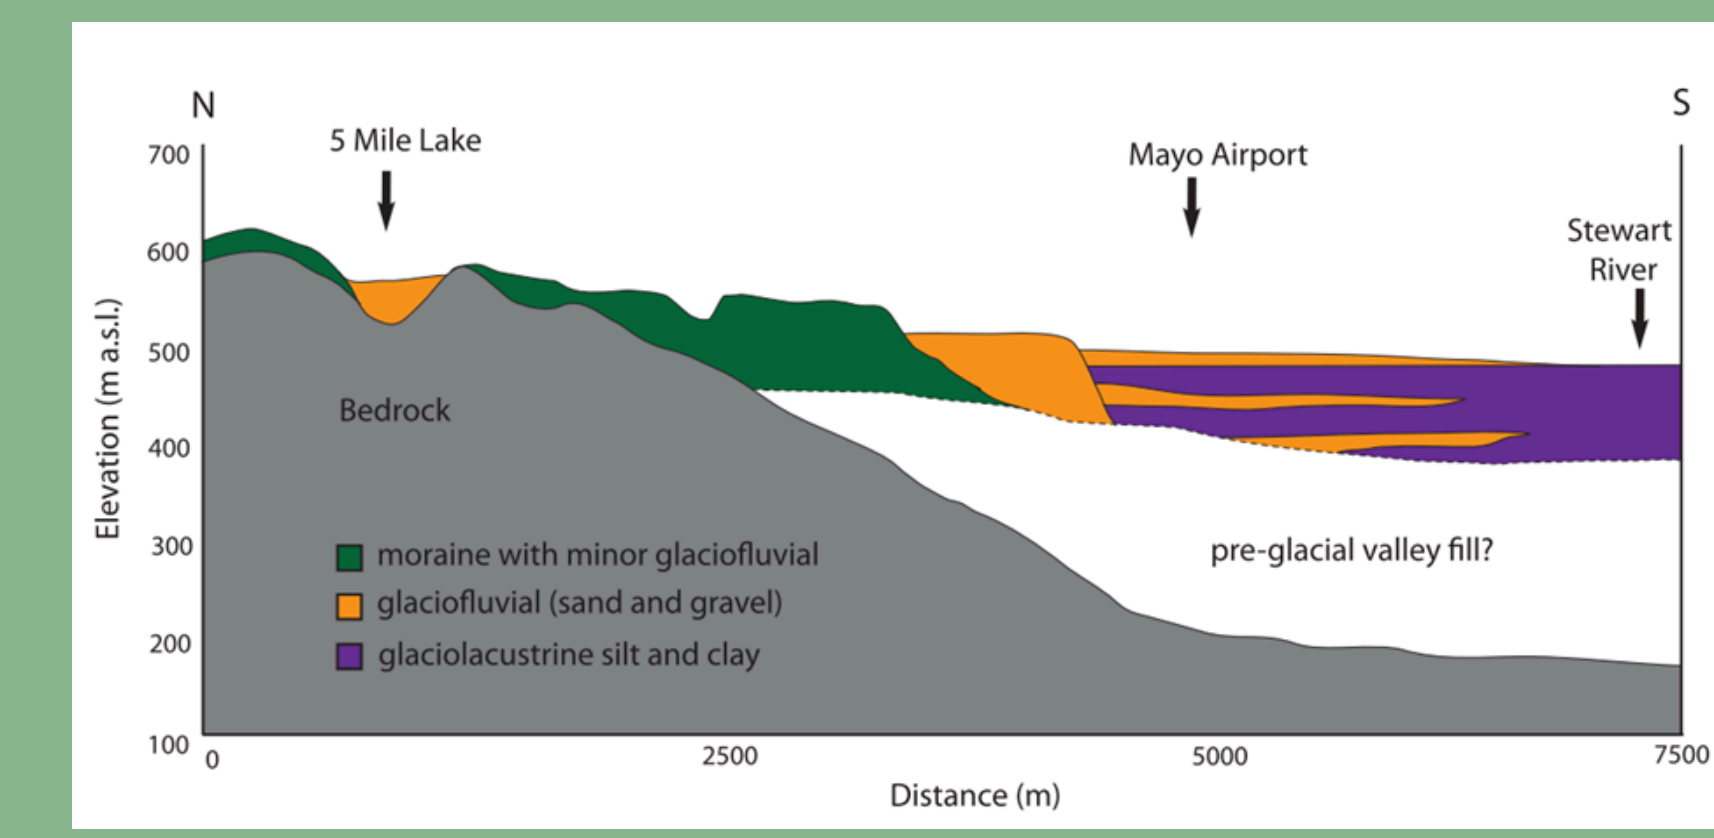
Figure 2: Geological cross section of the Mayo and Stewart River valley (Northern Climate Exchange, 2011).

In order to understand the spatial variability of thaw subsidence we see in the area today, we have to understand the glacial past that deposited the underlying sediments. Mayo was built on the floodplain of Nacho Nyäk Tagé (Stewart River; Fig. 1). During the late Pleistocene, the valley was covered by a glacial lake, that deposited a thick unit of fine-grained frost-susceptible sediments (Giles, 1993). This unit is partially overlain and interlaced by fluvial sediments from Mayo River to the north (fig. 2).

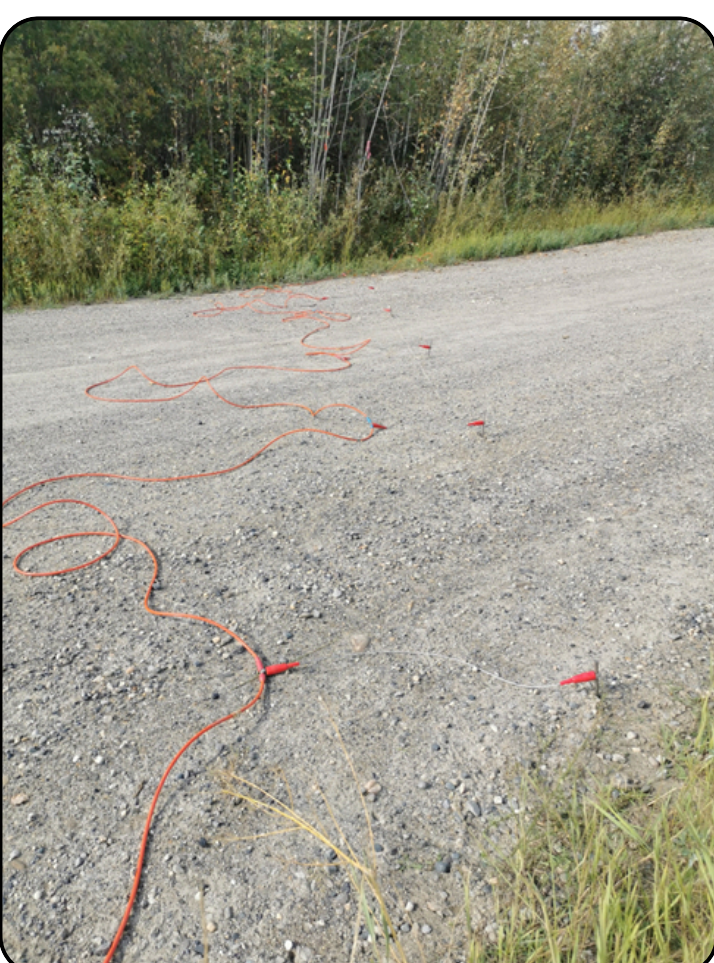
Figure 4: ERT survey line crossing a road.

Electrical resistivity tomography is a geophysical imaging technique that measures subsurface properties along a transect of tightly spaced electrodes. Warm, wet soils have a low electrical resistivity while frozen ice-rich soils have a very high resistivity (>1000 Ωm). This allows to infer permafrost conditions. Two 160 m long ERT surveys (figs. 6, 7) support the idea of highly variable permafrost conditions with variable ground ice content and thawed sections. This causes very small-scale variability in bottom down thaw that can be explained by differences in stratigraphy, disturbance history, and land cover.

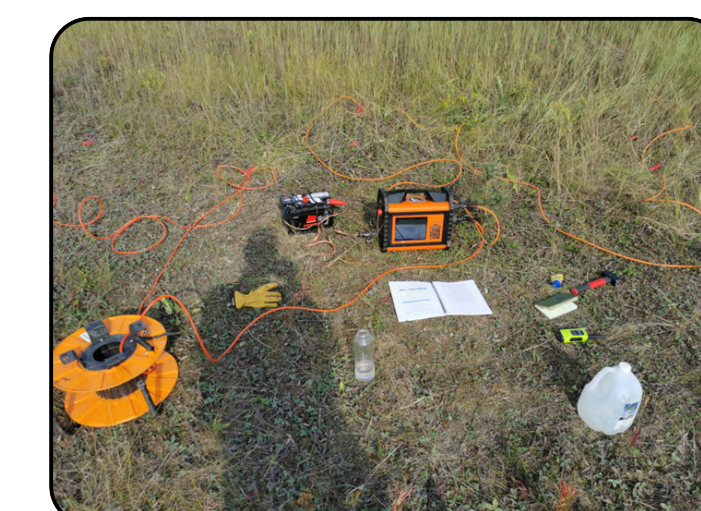
Figure 5: ABEM Terrameter LS 2 during data collection.

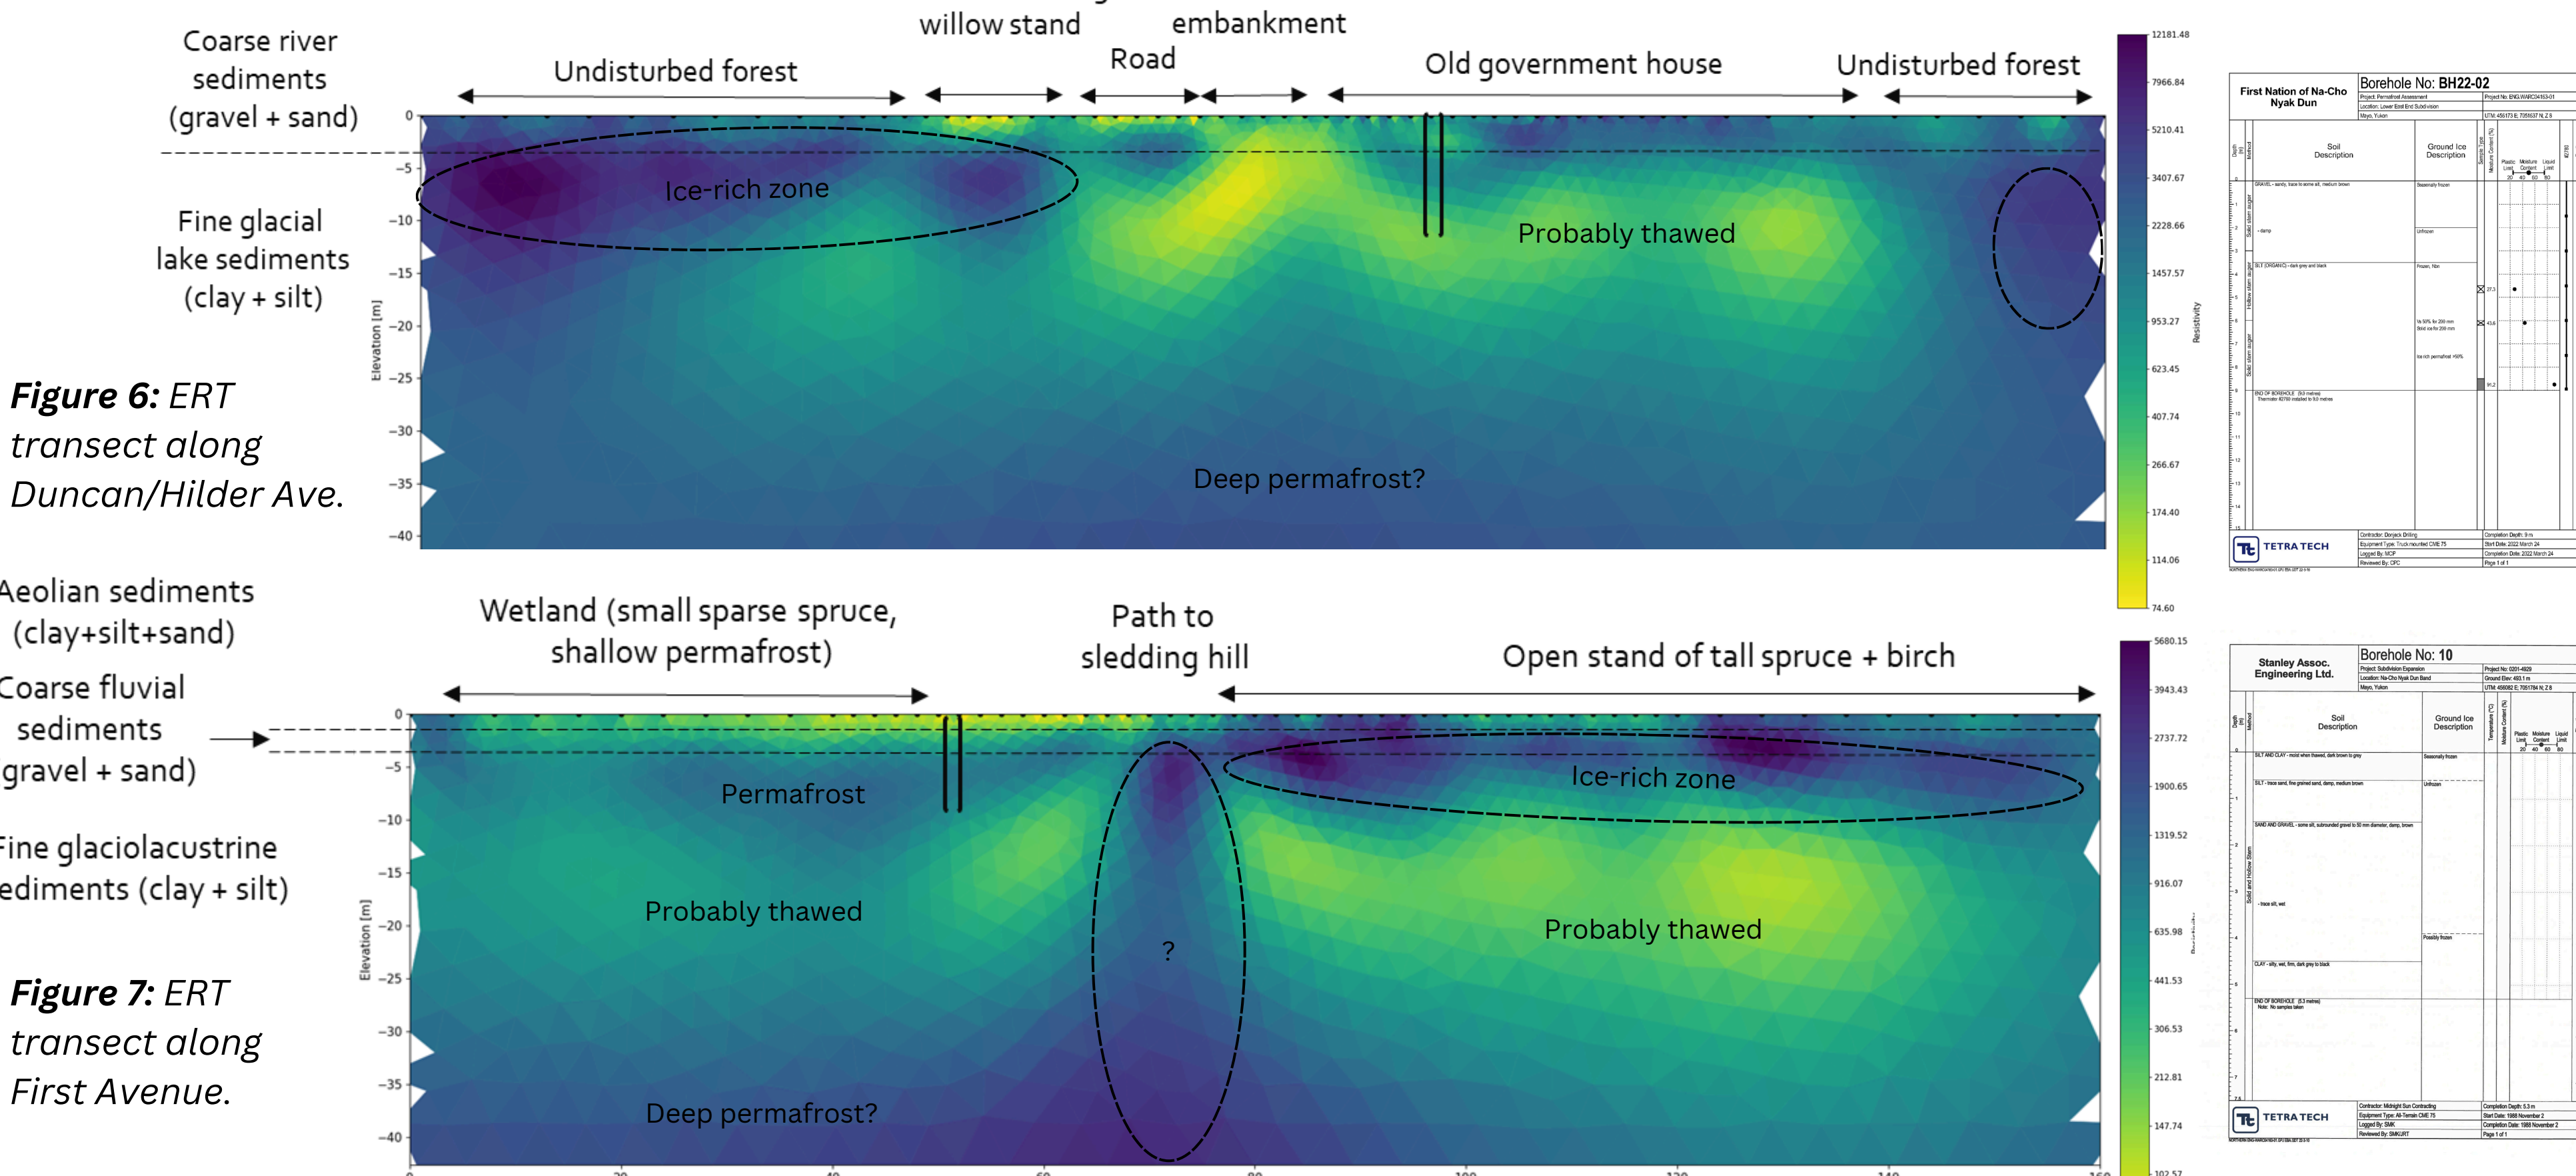
Figure 6: ERT transect along Duncan/Hilder Ave.

Figure 7: ERT transect along First Avenue.

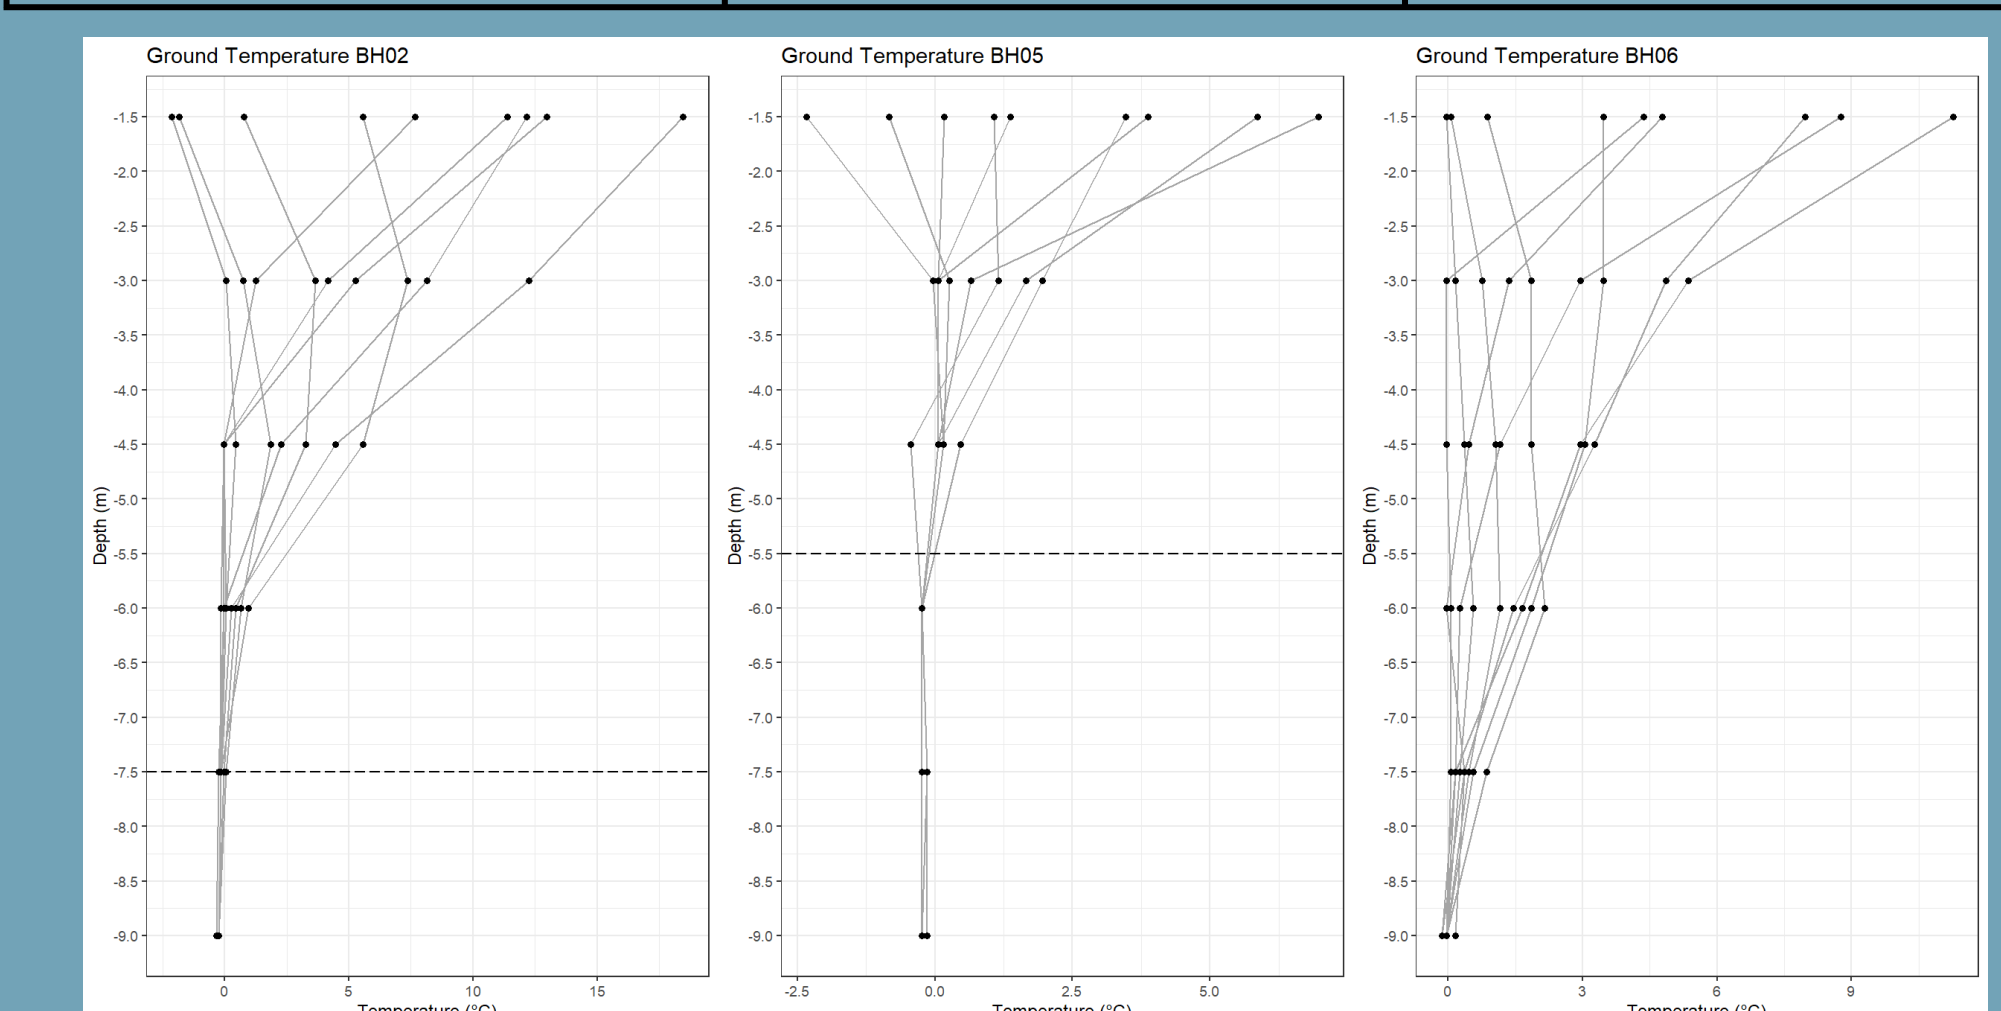
BH-02	BH-05	BH-06
Longest disturbance. Permafrost table at -7.5 m. Ice-rich at depth.	Latest disturbance (1990s). Shallowest permafrost (-5.5 m).	No pf table detected. Groundwater flow encountered during drilling.

Three boreholes were drilled by FNNND and Tetratich in May 2022 to assess ground conditions and establish long-term ground temperature monitoring. Permafrost tables were encountered during drilling but were later interpreted as deep seasonal frost using the collected data.
